Report No. UT-03.11

***INSTRUMENTATION AND
INSTALLATION SCHEME OF A
MECHANICALLY STABILIZED
EARTH WALL ON I-15 WITH
RESULTS OF WALL AND
FOUNDATION BEHAVIOR***

**Department of Civil &
Environmental Engineering
Utah State University**

**Utah Department of Transportation
Research Division**

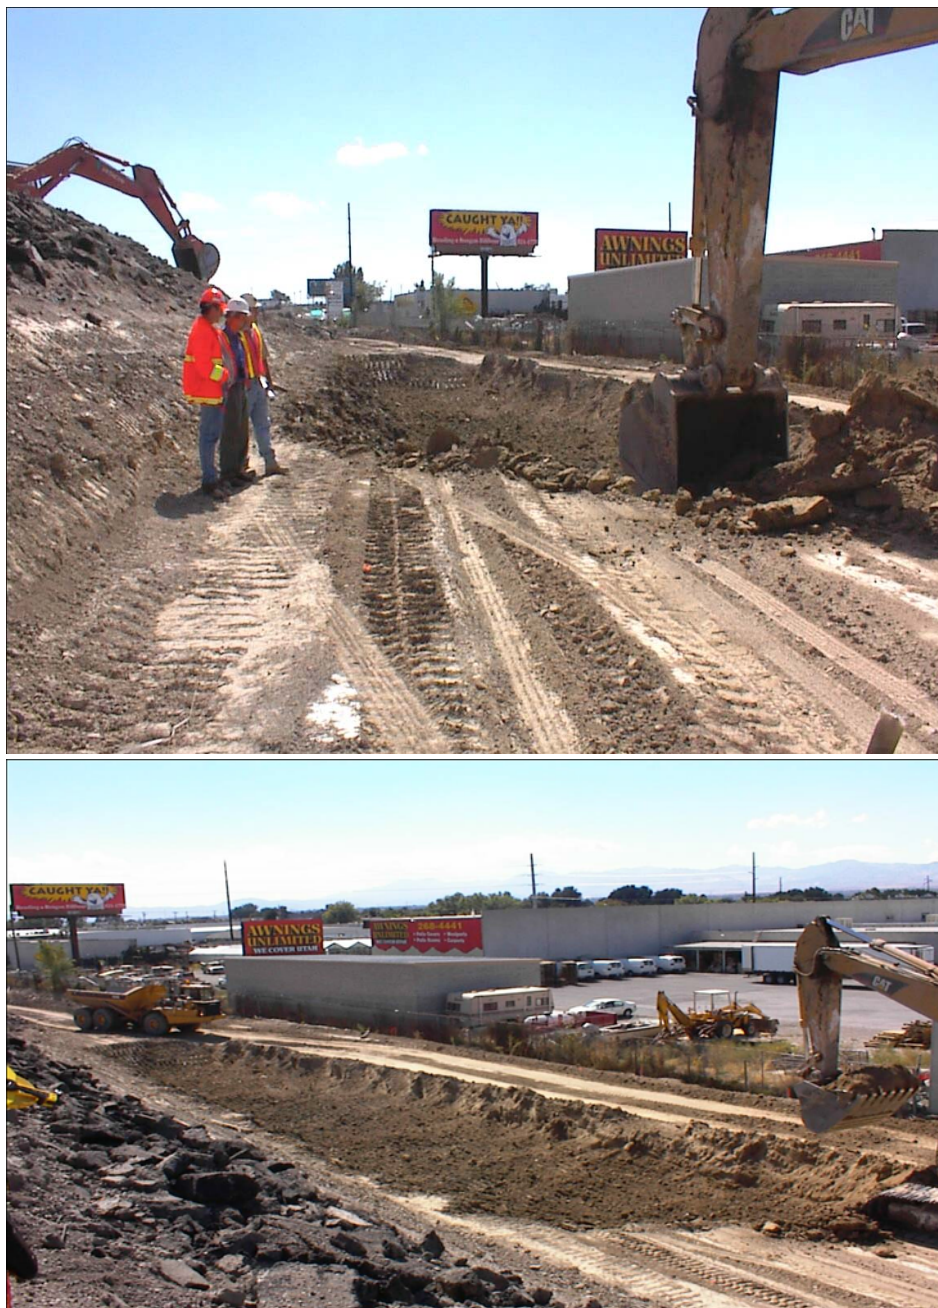
Figure 3.7. Photographs showing excavation of wall footprint prior to construction.

Prior to construction of the wall, roughly 8 ft (2.44 m) of soil was excavated from the site as shown in Figure 3.7, and replaced with concrete rubble and granular fill as illustrated by Figure 3.8. Beneath this fill material was a soft layer of clay to a depth of 19 ft (5.79 m), which was overlying soft silty clay, which extended to a depth of 30 ft (9.14 m). Below a depth of 30 ft (9.14 m), the soils at the site consisted of stiff to very stiff sandy clay to a depth of 85 ft (25.9 m) below grade overlying clay to a depth of 90 ft (27.4 m), the maximum depth explored.

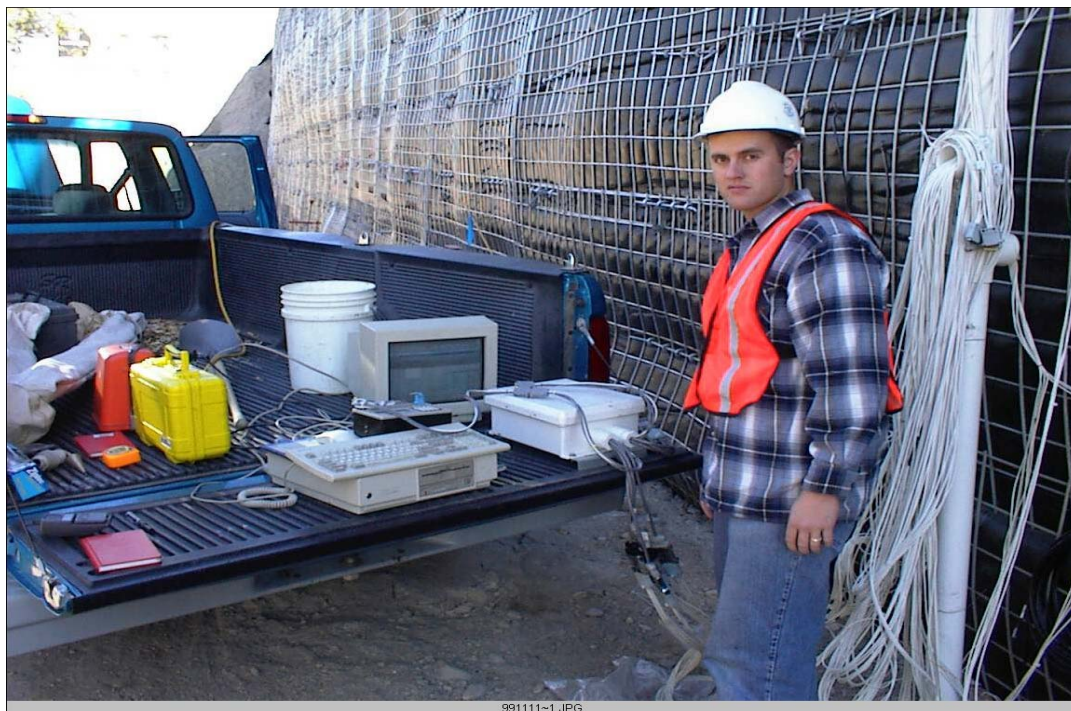
Figure 4.10. Photograph showing data acquisition system and exiting strain gage cables from PVC conduit.

The lead wires from the gages were bundled into four different sets for each instrumented layer. These bundled lead wires then exited the face of the wall and traveled through a 3 inch (76.2 mm) diameter Schedule 40 PVC pipe and exited the PVC pipe near the base of the wall as shown in Figure 4.10. Each set of wires was soldered to a connector, which could be quickly connected into the data acquisition system shown in Figure 4.11. The fascia panels were wired using the same method as was used on the primary and intermediate bar mats. However, the lead wires ran directly down the face of the wall and not through the 3 inch (76.2 mm) PVC pipe. This was done due to the lack of space inside the PVC pipe.

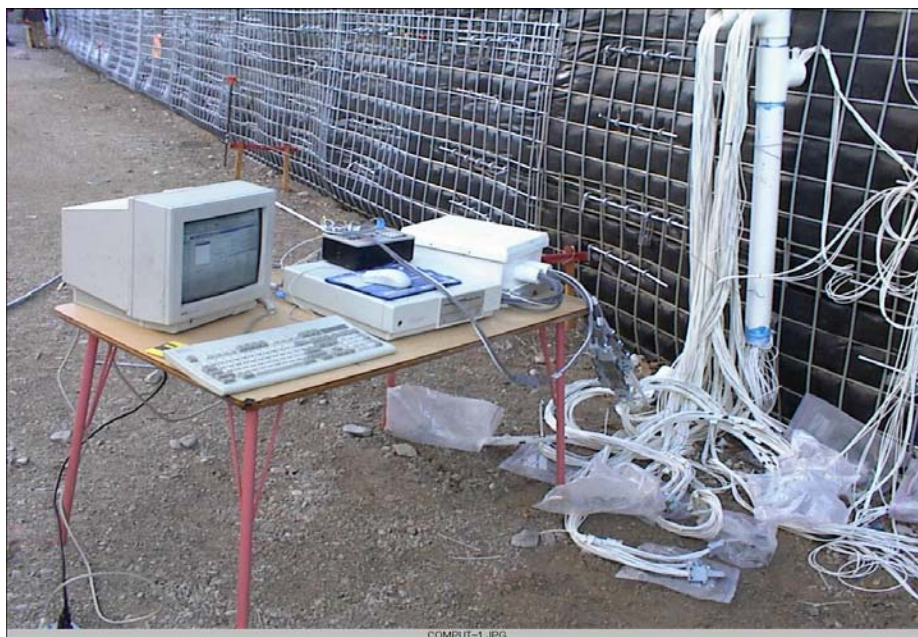
Figure 4.11. Photograph of data acquisition system showing the 21X datalogger, AM416 multiplexer with enclosure, and the computer containing the Campbell-Scientific program used to take and store strain gage readings.

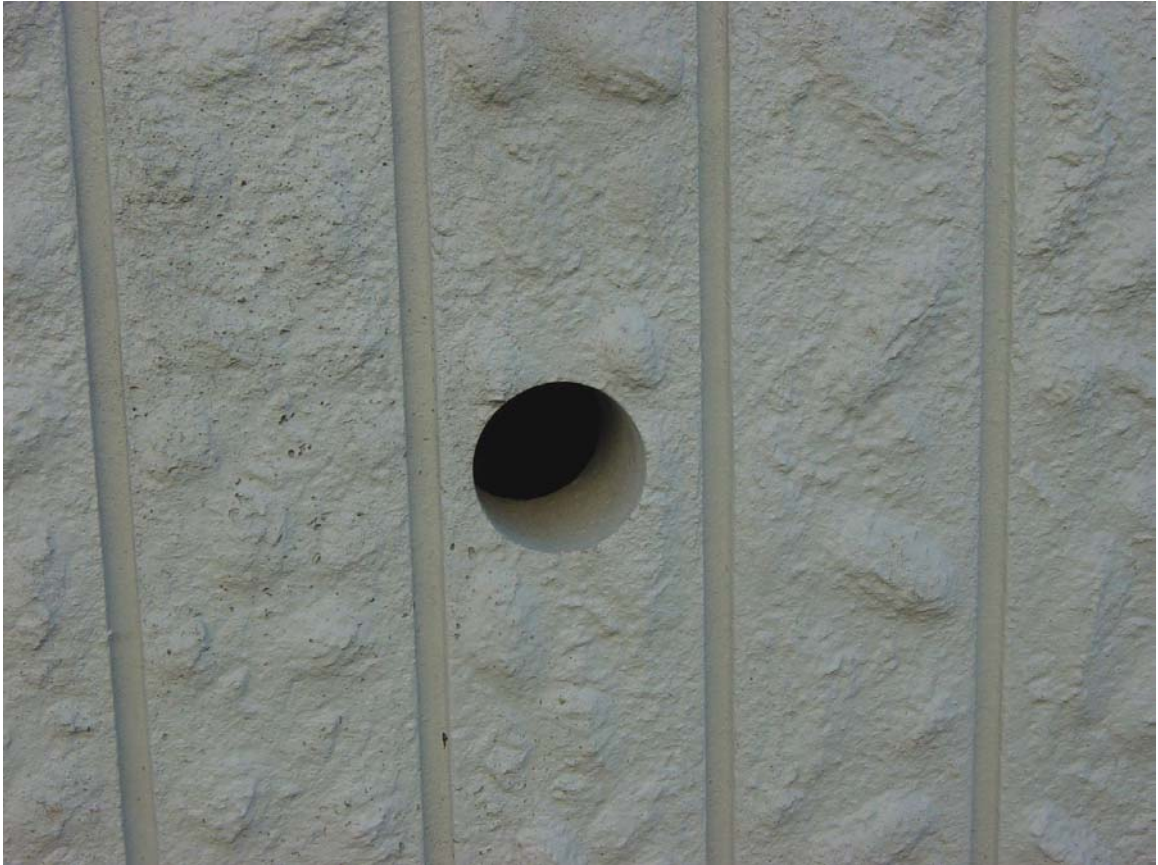
Figure 6.1. Hole cored in secondary stage concrete fascia panel to allow access (Inclinometer H2).

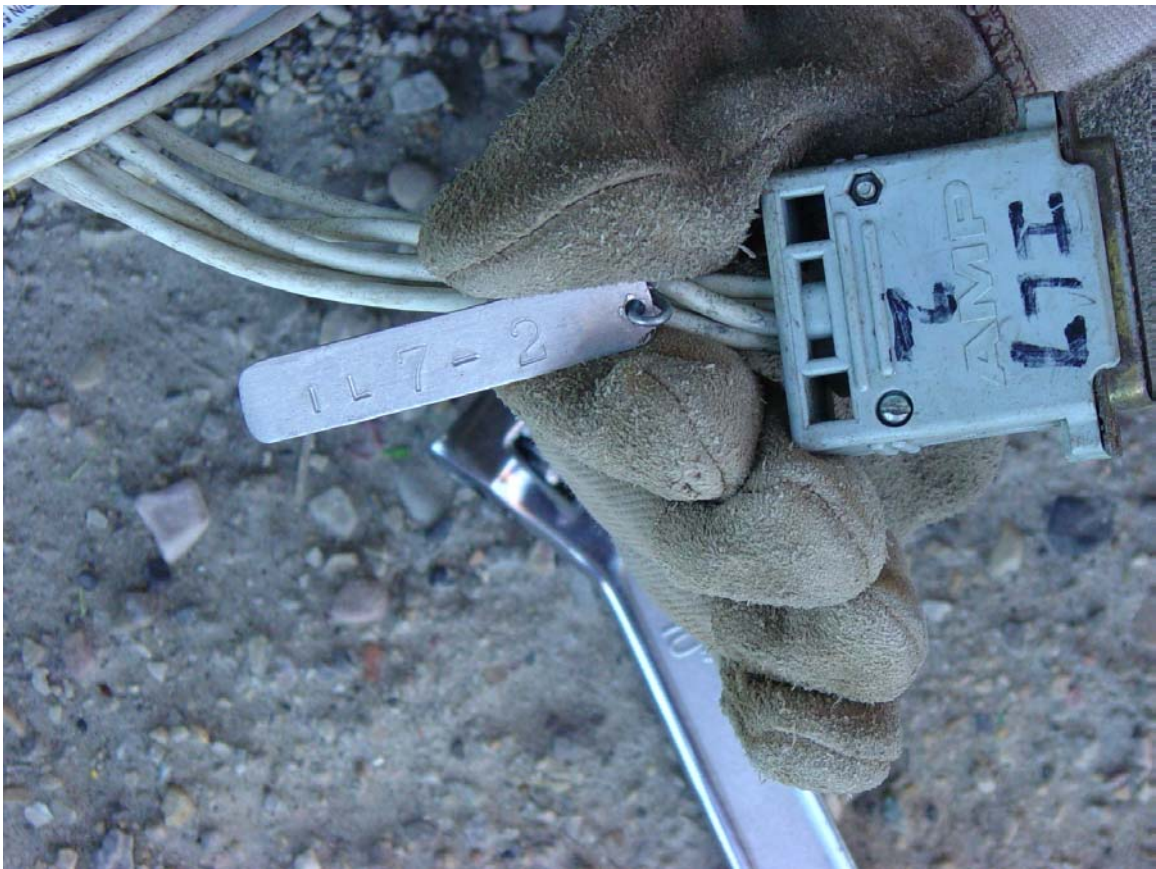
Figure 6.2. Aluminum tags used to label the strain gage connectors.

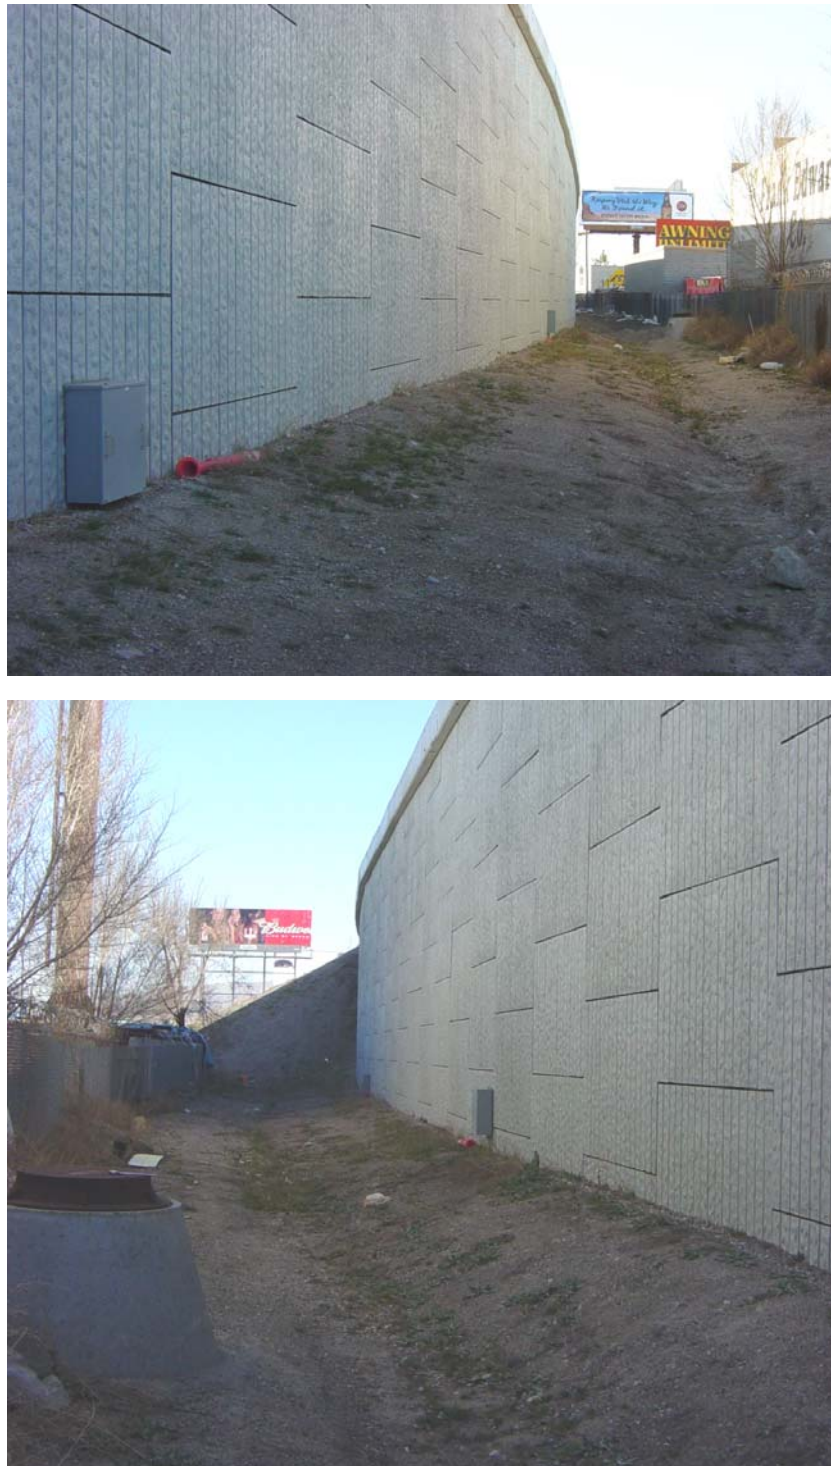
Figure 6.3. Views from the North and South, respectively, showing the two electrical boxes containing strain gage cables and connectors for the two instrumented sections of wall.

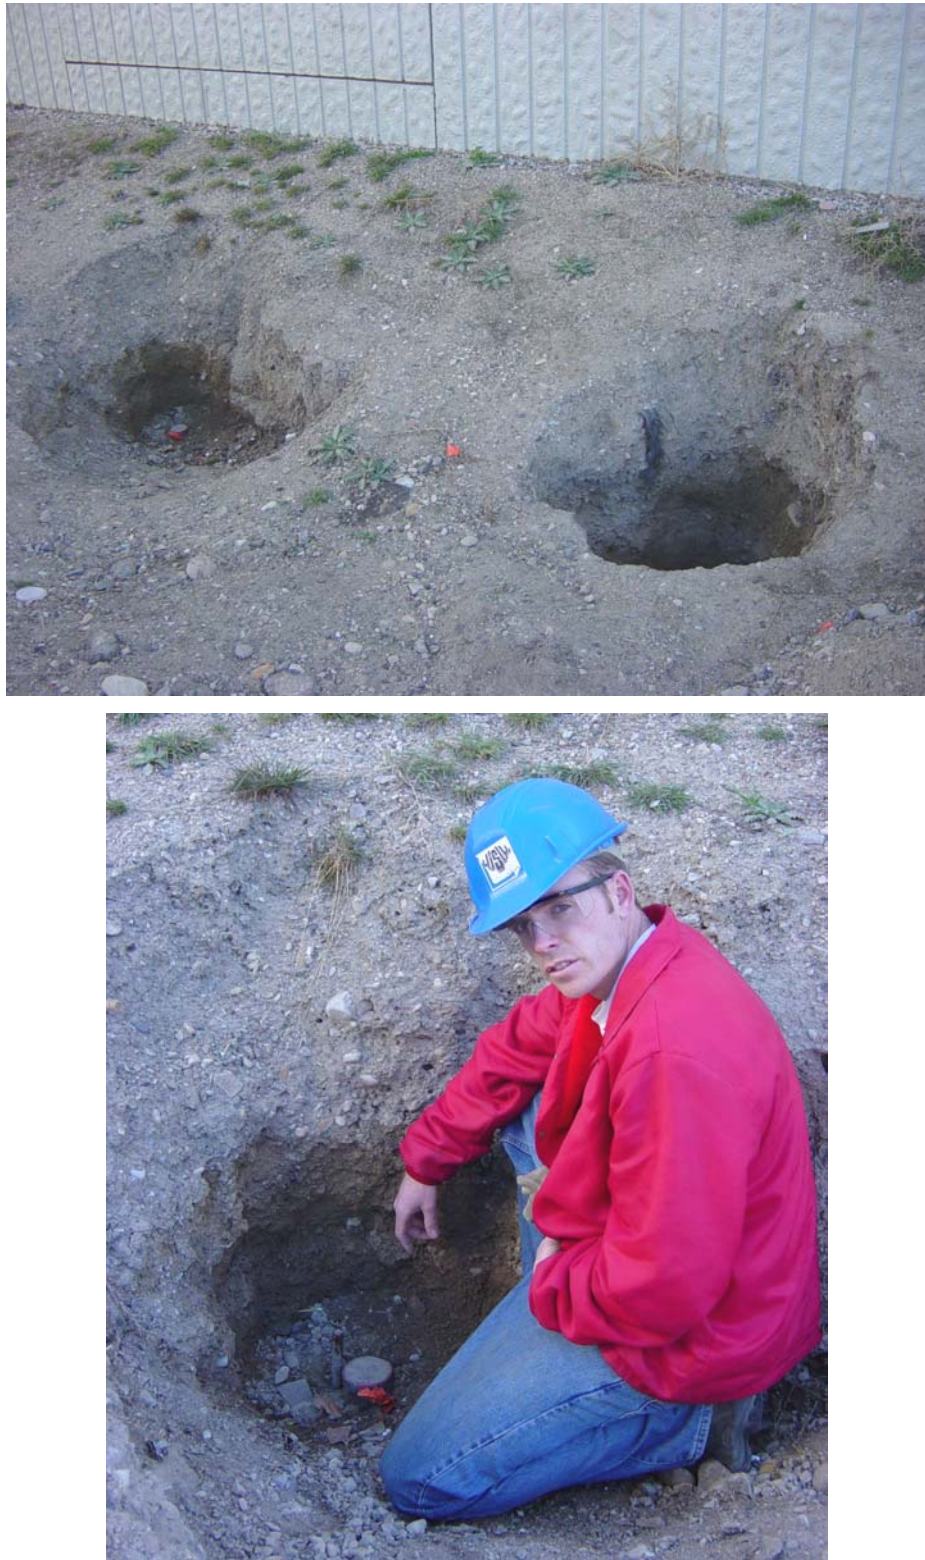
Figure 6.11. Photographs showing the recovered inclinometer I2 casing (on the left in upper photo).

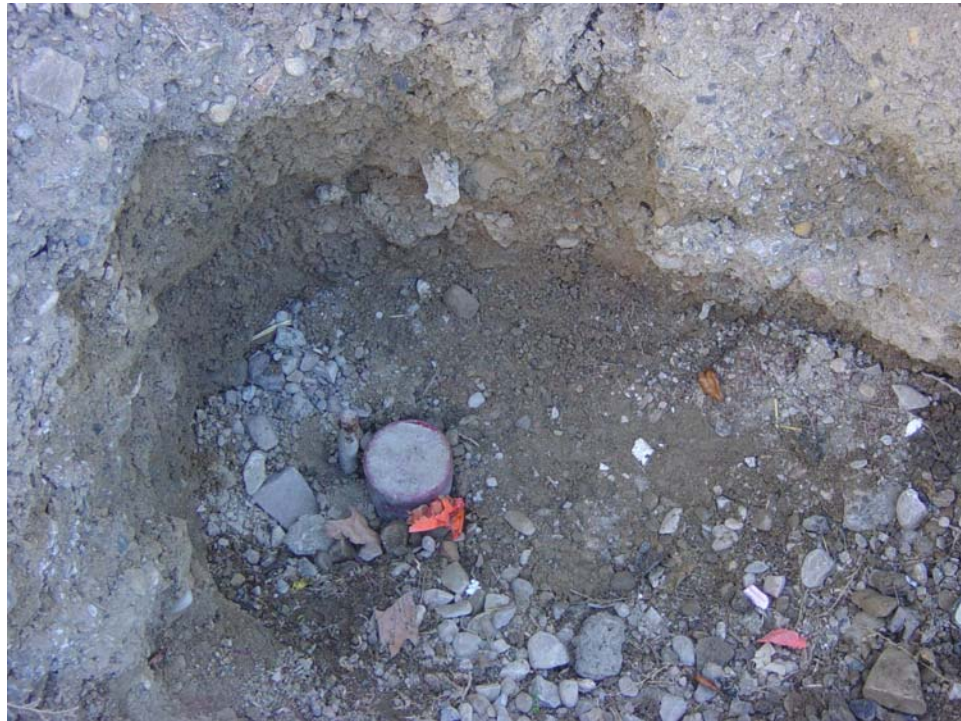
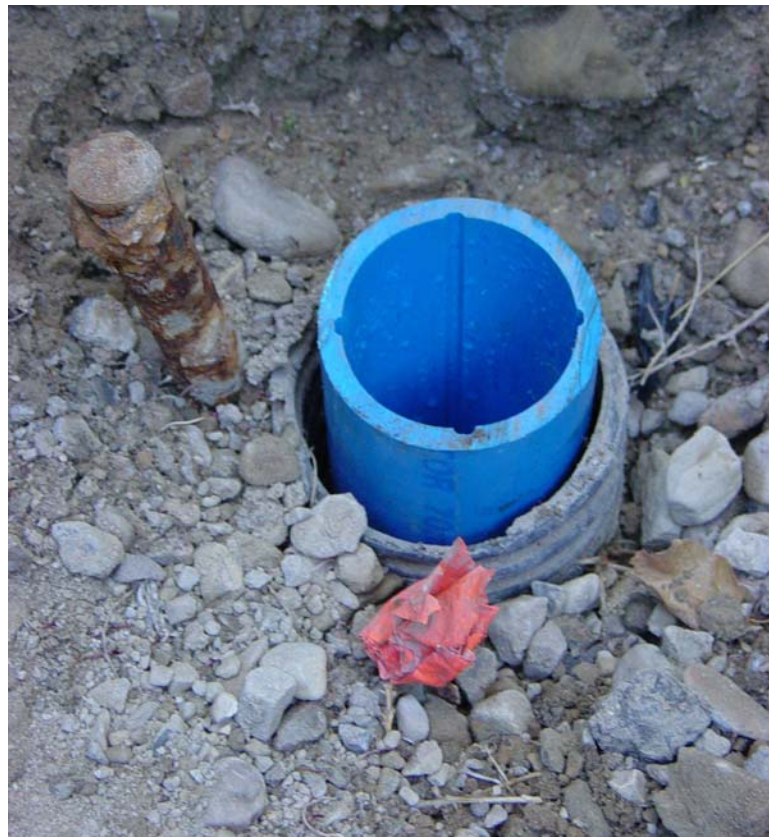
Figure 6.12. Additional photographs showing the recovered inclinometer I2 casing.

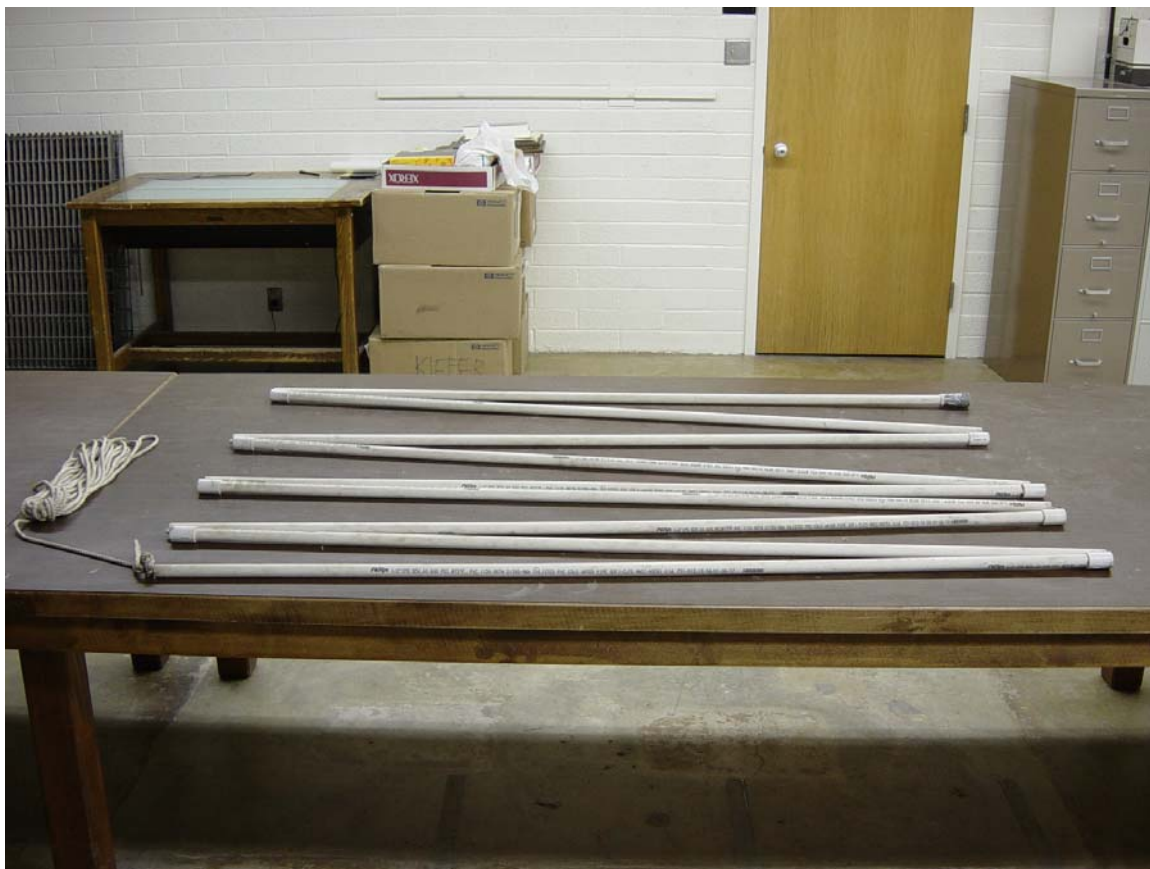
Figure 6.21. Photograph showing the interconnectable PVC pipes used to push the horizontal inclinometer into the H2 casing.

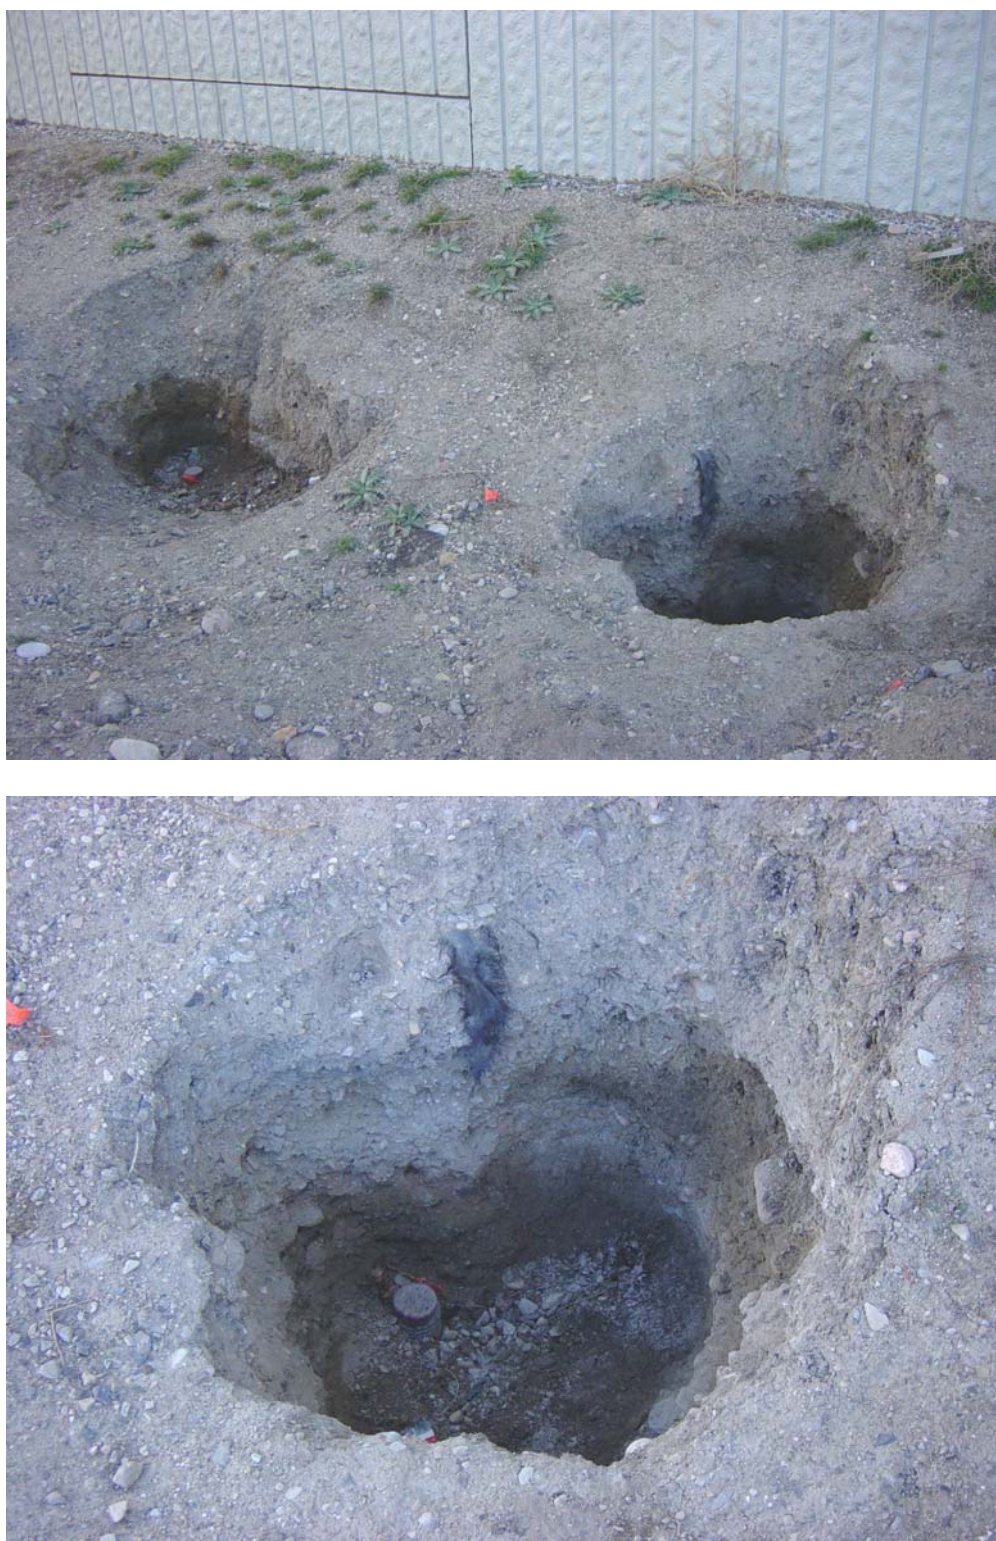
Figure 6.28. Photographs of recovered Sondex casing S2 (at right in upper photograph).
